PSP2211

To: All Spectracom customers with a Premium Support Package  
Subject: Notification of an available NTP TimeServer Software Update  
From: Keith Wing, Spectracom Customer Service Manager  
David Lorah, Customer Service Technician

We at Spectracom Corporation continuously strive to improve our products. To this end, we have released a software update (Application software version 3.4.1) for the Spectracom NetClocks (Models 9383, 9389, 9283, and 9289) and the Ethernet Time Server (Model 9288).

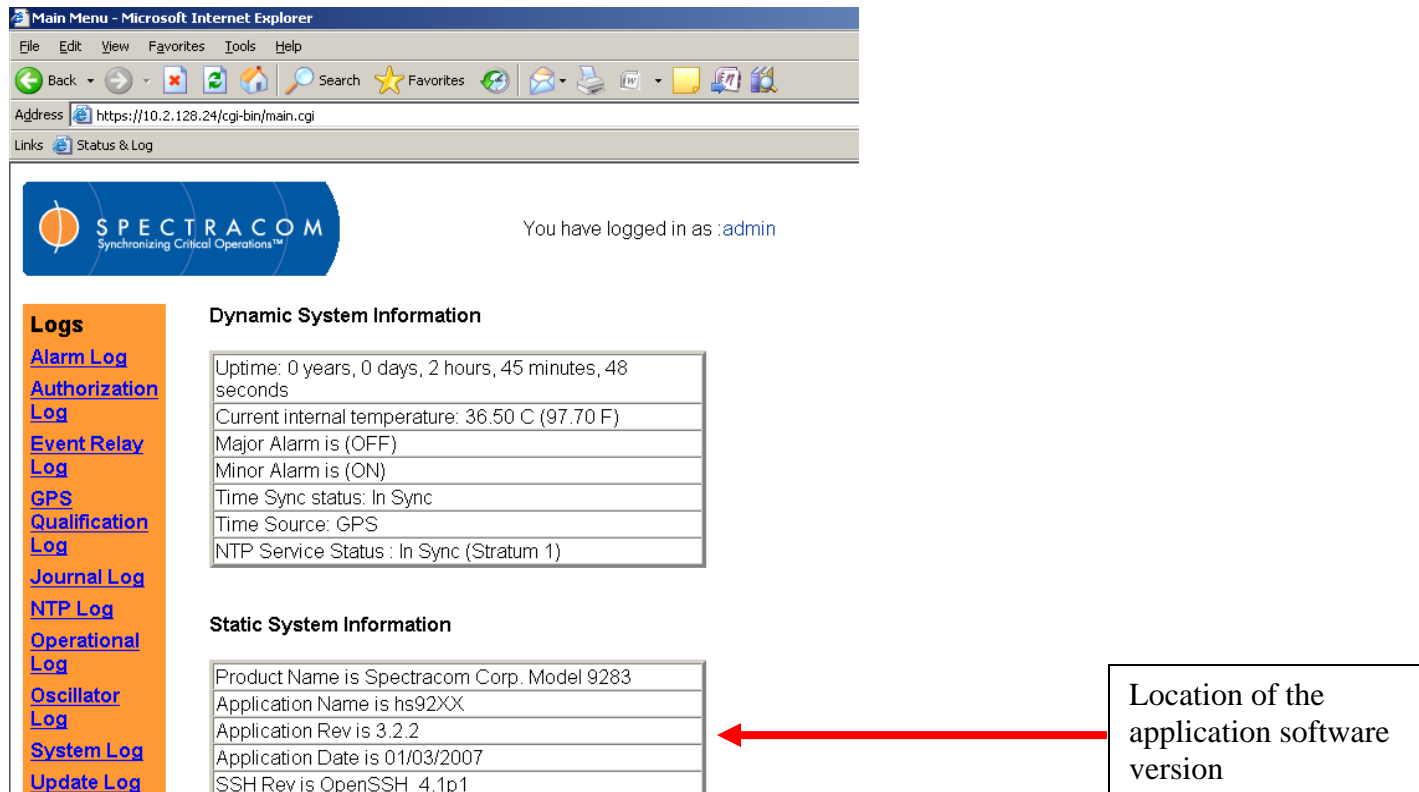
**Figure 1: Application Software Revision Contained on the System Status Page**

To determine the current application software version of your NetClock or Ethernet Time Server, log in to the unit's web browser user interface. Click on "Status and Logs" located on the bottom menu and then on "System Status" located on the left menu. Scroll down to the "Static System Information" box, which contains a line stating "Application Rev is." The number next to this is the current application software version. Refer to Figure 1.
